**Flood Control Project Maintenance
Levee Inspections**

2016 Channel Summary Report

San Joaquin County Flood Control and Water Conservation District

Flood Control Project Maintenance**Unit Cover Sheet****2016 Channel Inspection Results****San Joaquin County Flood Control and Water Conservation District**

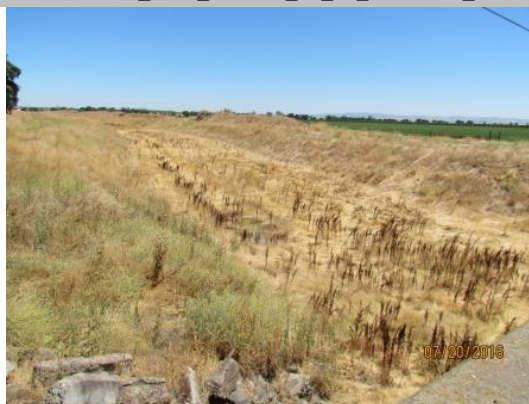
Photo 1 of 1 : CH_2016_NA0017_43_11_20160801_00014.jpg

View of the vegetation in the channel looking upstream.

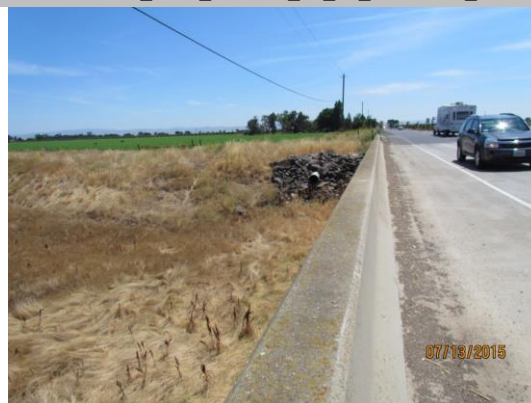
Photo 1 of 2 : CH_2016_NA0017_43_14_20160613_00003.jpg

View of the revetments on the left bank of the channel looking upstream.

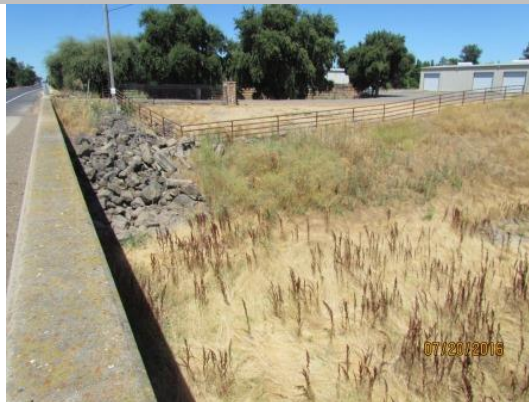
Photo 2 of 2 : CH_2016_NA0017_43_14_20160801_00016.jpg

View of the revetments on the right bank of the channel looking upstream.

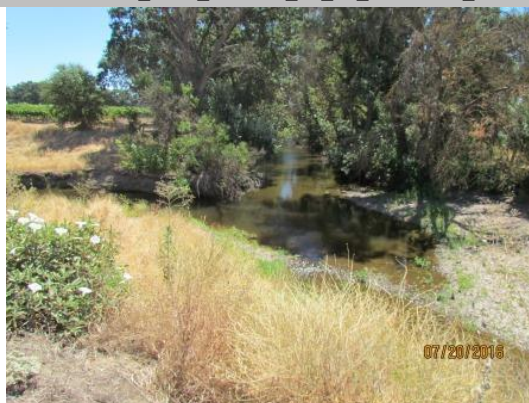
Photo 2 of 4 : CH_2016_NA0017_43_21_20160801_00020.jpg

View of the confluence during 2016 inspection.

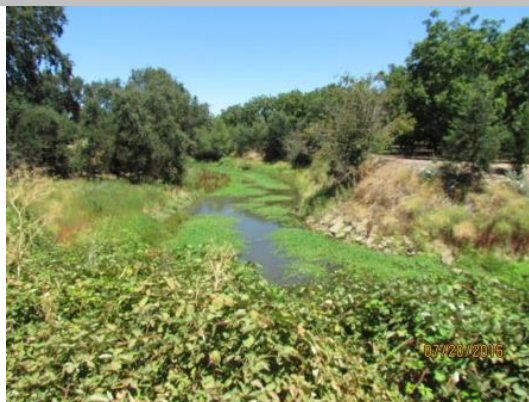
Photo 1 of 1 : CH_2016_NA0017_42_6_20160802_00033.jpg

Rating **	A	Issue No.	6	GPS Lat/Long
Issue Type +	Ma	Location *		37.919430 °
Category	Rivers, Channels & Designated Flood			-121.034800 °
Item	Vegetation & Obstructions			
DWR ID	DWR_NA0017_42_c_2012_6			
Action/Comments				
Inspector Comments: Minimal vegetation was found, but they do not obstruct the flow of the channel.

View of the vegetation on the upstream of the channel.

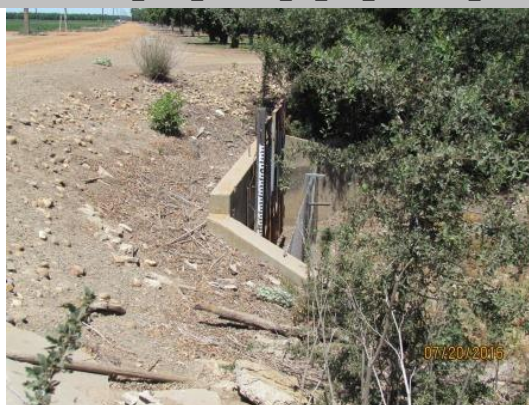
Photo 1 of 1 : CH_2016_NA0017_42_112_20160802_00035.jpg

Inspector Comments: The concrete surface appeared to be in good condition with no negligible spalling, scalling or cracking.

View of the culvert on the upstream of the channel.

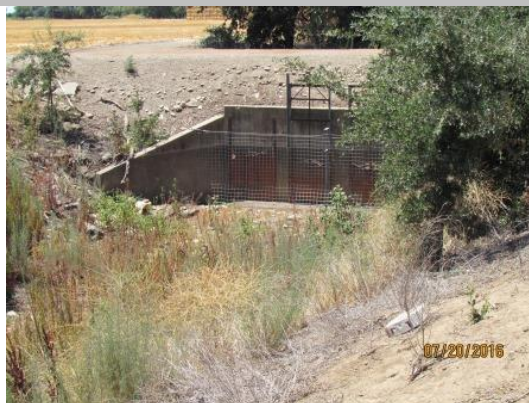
Photo 1 of 1 : CH_2016_NA0017_42_113_20160802_00036.jpg

Rating **	M	Issue No.	113	GPS Lat/Long
Issue Type +	Ma	Location *		37.920600 °
Category	Rivers, Channels & Designated Flood			-121.037920 °
Item	Gates			
DWR ID	DWR_NA0017_42_c_2012_113

Inspector Comments: Slide gates appeared to be in good operational condition, but gate wheels were missing from the gate.

View of the slide gate on the upstream of the channel.

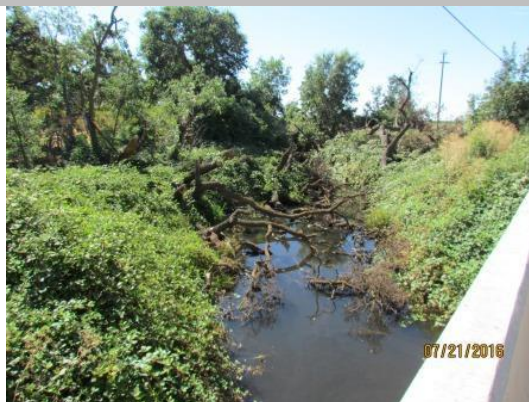
Photo 1 of 2 : CH_2016_NA0017_42_21_20160802_00038.jpg

Inspector Comments: Tree branches and vegetation growth on the channel may cause an obstruction in the flow.

View of the tree branches on the channel looking upstream during 2016 inspection.

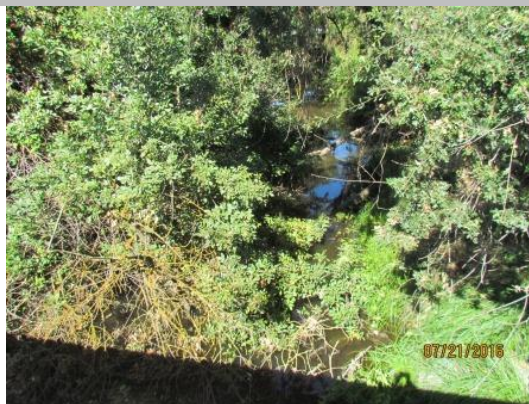
Photo 1 of 2 : CH_2016_NA0017_42_26_20160802_00039.jpg

View of heavy vegetation looking downstream of the channel during 2016 inspection.

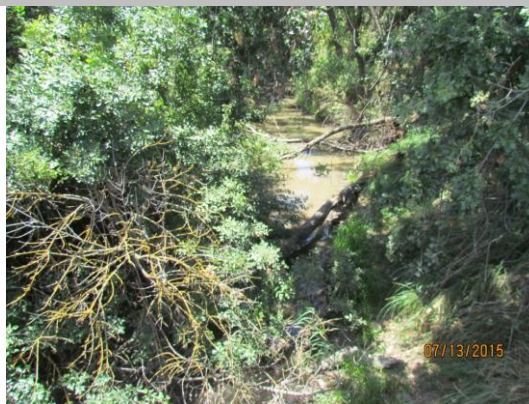
Photo 2 of 2 : CH_2016_NA0017_42_26_20160613_00006.jpg

Rating **	U*	Issue No.	26 (cont)	GPS Lat/Long
Issue Type +	Ma	Location *		37.918960 °
Category	Rivers, Channels & Designated Flood			-121.056260 °
Item	Vegetation & Obstructions			
DWR ID	DWR_NA0017_42_c_2012_26

View of heavy vegetation looking downstream of the channel.

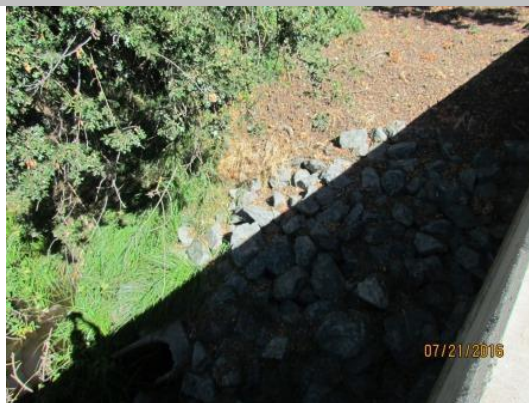
Photo 1 of 1 : CH_2016_NA0017_42_29_20160802_00040.jpg

Inspector Comments: Existing revetments were found.

View of existing revetments on the right bank of the channel looking downstream.

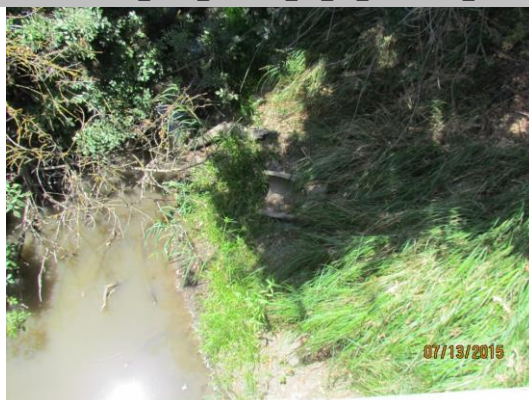
Photo 1 of 1 : CH_2016_NA0017_42_30_20160613_00007.jpg

Inspector Comments: A broken pipe was found on the bank of the channel during inspection.

View of the broken pipe on the downstream of the channel.

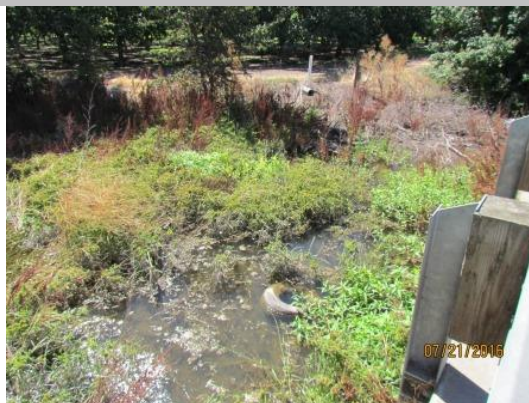
Photo 1 of 1 : CH_2016_NA0017_42_35_20160802_00042.jpg

View of debris on the channel looking upstream.

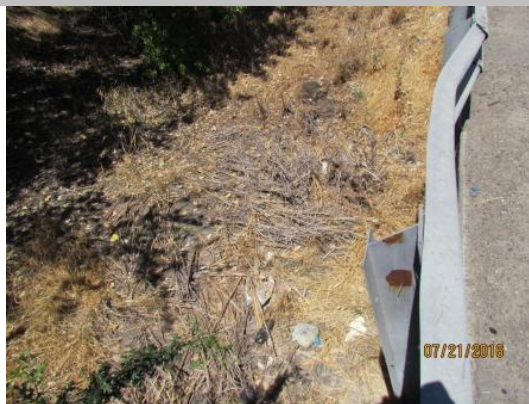
Photo 1 of 1 : CH_2016_NA0017_42_50_20160802_00046.jpg

View of debris in the downstream end of the channel.

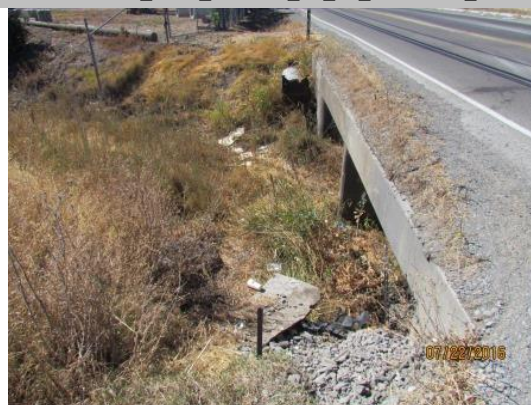
Photo 1 of 2 : CH_2016_NA0017_42_55_20160803_00048.jpg

View of debris on the upstream of the channel during 2016 inspection.

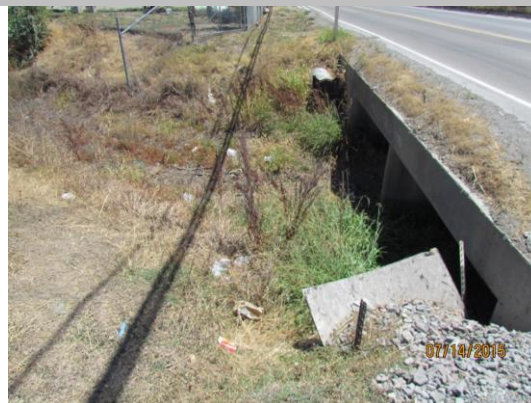
Photo 2 of 2 : CH_2016_NA0017_42_55_20160613_00018.jpg

View of the encroachments on the upstream of the channel.

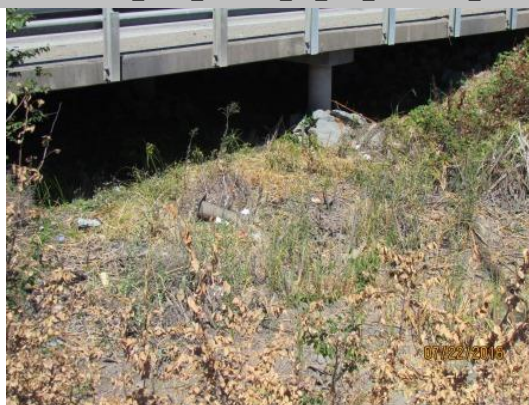
Photo 1 of 1 : CH_2016_NA0017_42_105_20160803_00059.jpg

View of debris on the upstream end of the channel during 2016 inspection.

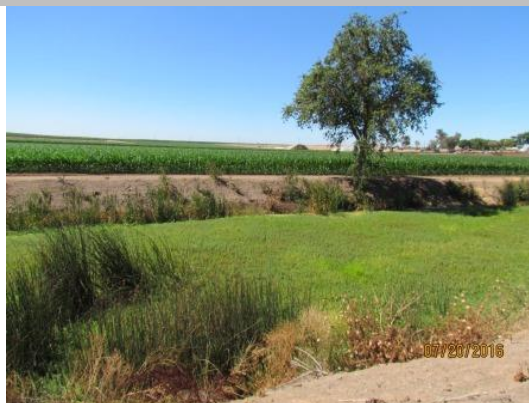
Photo 1 of 2 : CH_2016_NA0017_44_8_20160726_00053.jpg

Rating **	A	Issue No.	8	GPS Lat/Long
Issue Type +	Ma	Location *		37.900914 °
Category	Rivers, Channels & Designated Flood			-120.934604 °
Item	Erosion / Bank Caving			
DWR ID	DWR_NA0017_44_c_2012_8			
Action/Comments				
Inspector Comments: Erosion is repaired.

Erosion on the left bank of the channel is repaired. The picture was taken looking downstream during 2016 inspection.

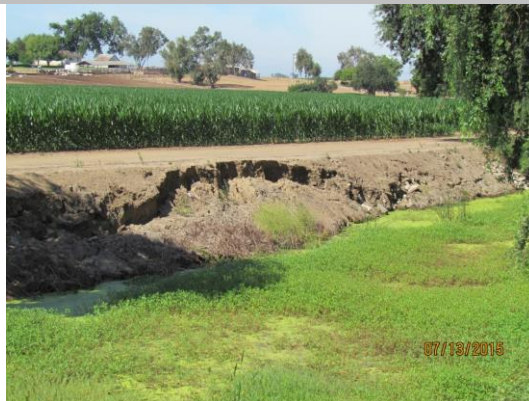
Photo 2 of 2 : CH_2016_NA0017_44_8_20160720_00002.jpg

View of the erosion on the left of the channel looking downstream during 2015 inspection.

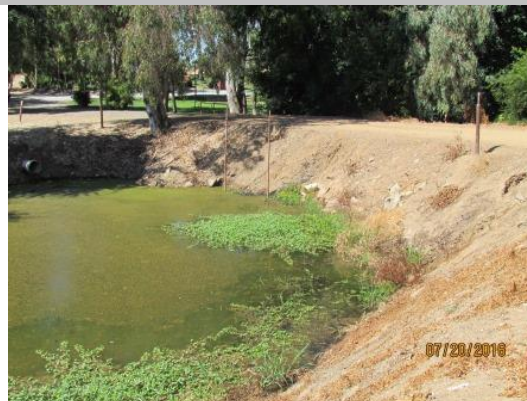
Photo 1 of 1 : CH_2016_NA0017_44_108_20160726_00056.jpg

Inspector Comments: The pipe appeared to be in good condition, but accumulated debris may block the flow inside the pipe.

View of the pipe looking upstream of the channel.

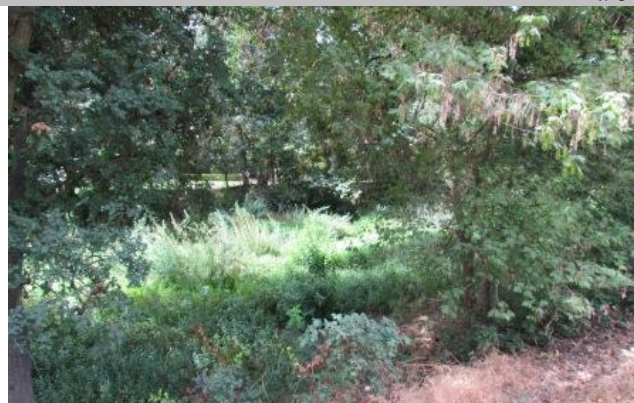
Photo 1 of 1 : CH_2016_NA0017_44_107_20160720_00042.jpg

View of obstructions on the channel looking upstream.

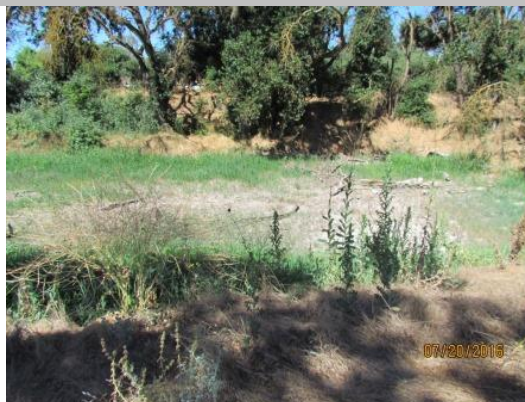
Photo 1 of 1 : CH_2016_NA0017_44_144_20160726_00060.jpg

Inspector Comments: Debris was found that could obstruct the flow of the channel.

View of debris on the channel looking upstream.

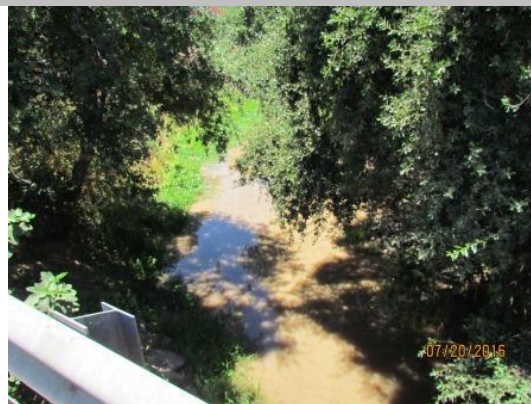
Photo 1 of 1 : CH_2016_NA0017_44_36_20160802_00068.jpg

Tree branches might obstruct the flow of the channel looking downstream.

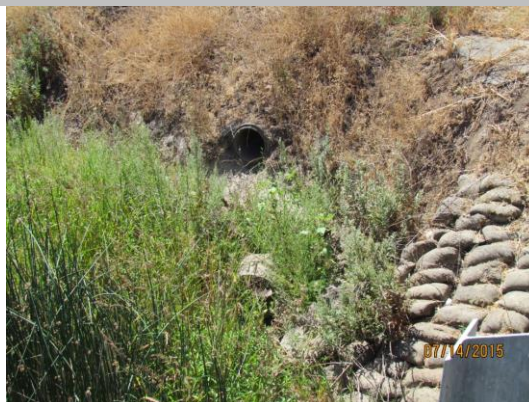
Photo 2 of 1 : CH_2016_NA0017_44_70_20160720_00030.jpg

View of a pipe with missing flap gate on the upstream of the channel.

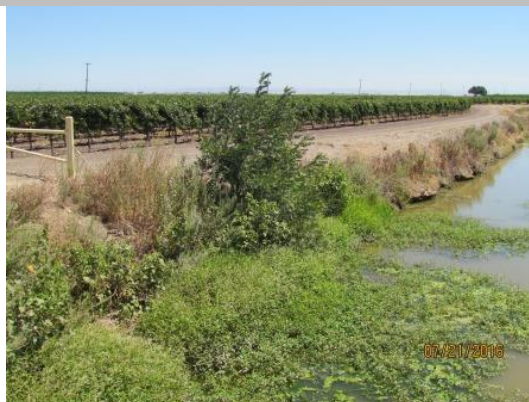
Photo 1 of 1 : CH_2016_NA0017_45_23_20160803_00022.jpg

View of erosion on the right bank of the channel looking upstream.
